Section 3.0 Errata

In accordance with Section 15132 of the CEQA Guidelines, the FEIR for the Beaumont Summit Station Project includes the DEIR, dated April 2022, as well as any proposed revisions or changes to the DEIR.

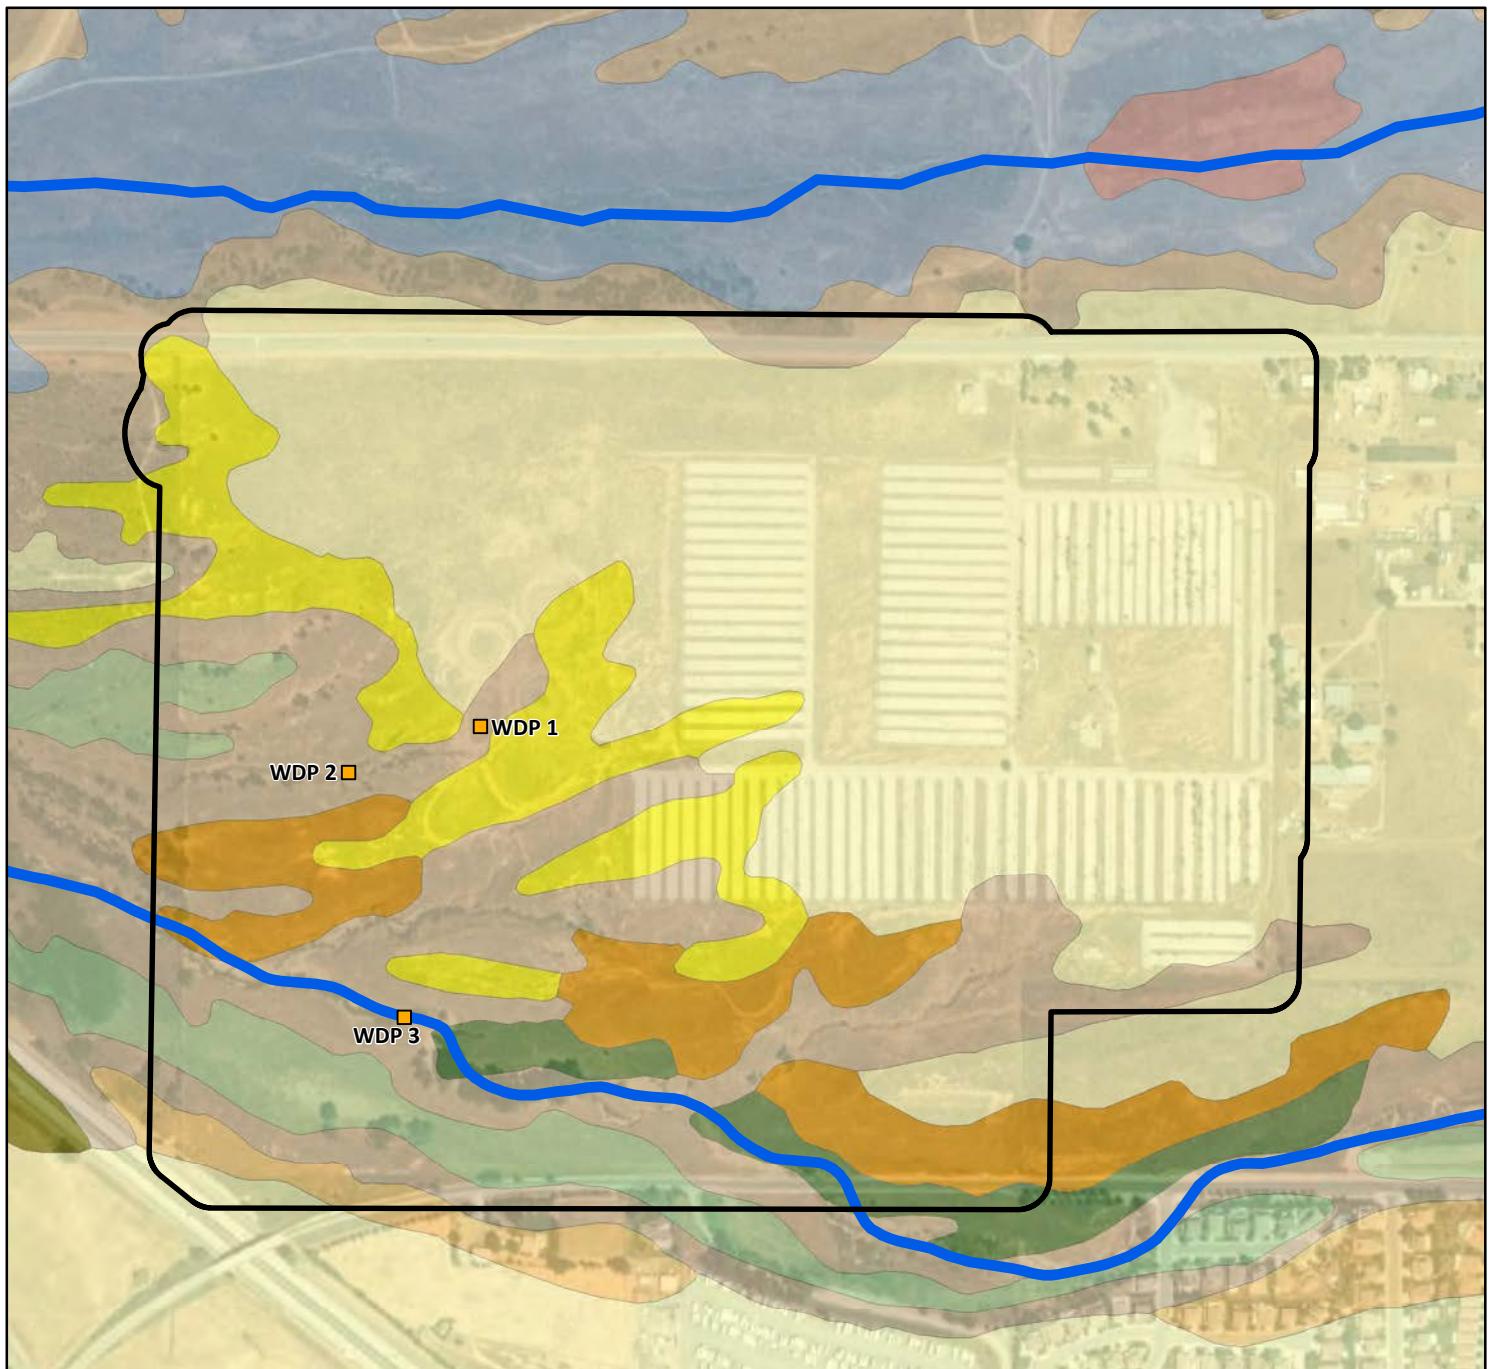
○ ARDR Review Area

■ Wetland Data Form Point (WDP)

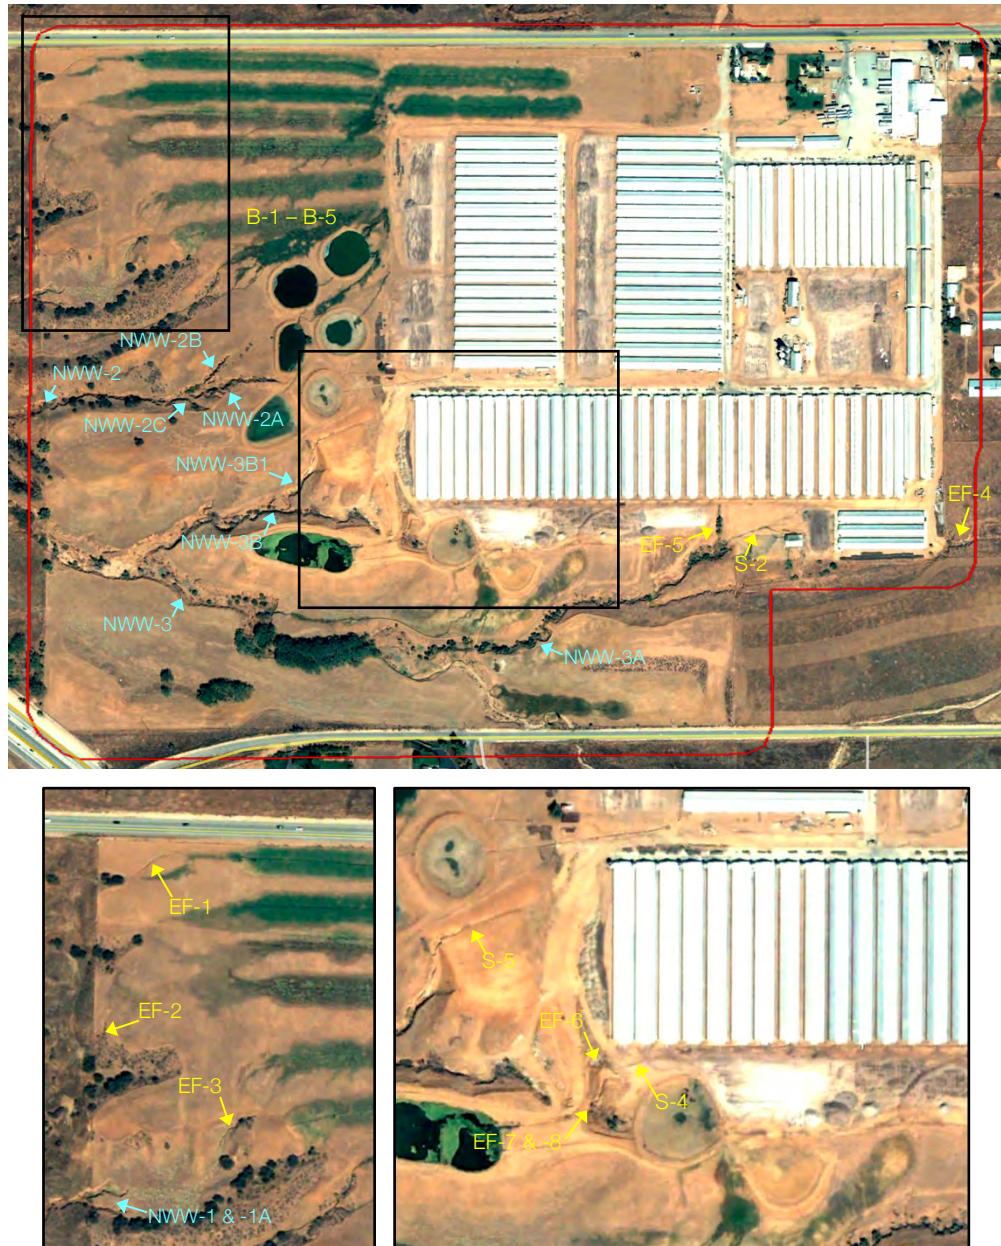
September 1996 – Farming operations within the review area continue to expand between February 1976 and September 1996 with the development of more poultry sheds in the center of the review area. Additionally, various ponding basins (i.e., B-1 and B-2) were developed within the review area during this time. Remains of these developments and site modifications exist to this day. B-1 and B-2 appear to drain runoff into NWW-2 and NWW-2B. Furthermore, an unnamed basin in the center of the review area drains into NWW-3B. The drainage between the unnamed basin and NWW-3B accounts for a portion of present-day NWW-3B and EF-8. NWW-1, NWW-1A, NWW-3, and NWW-3A are visible on the aerial in their current locations and extents. NWW-2C is evident but less distinguishable in the September 1996 aerial. The review area still appears to be regularly mowed. The expanding farming operations contribute to further reduction of NWW-3B and NWW-3B1. NWW-2A is not distinguishable in the September 1996 aerial.

EF-1 through EF-3 are not apparent. EF-4 is still defined and visible. EF-5 is now visible and appears to receive runoff from the newly constructed poultry sheds. B-3 through B-5 are not visible/present in September 1996. S-1 is evident in the September 1996 aerial but appears to be losing further definition. Some evidence of S-3 is visible; however, the feature is less distinguishable. D-1, S-4, and S-5 are not visible.

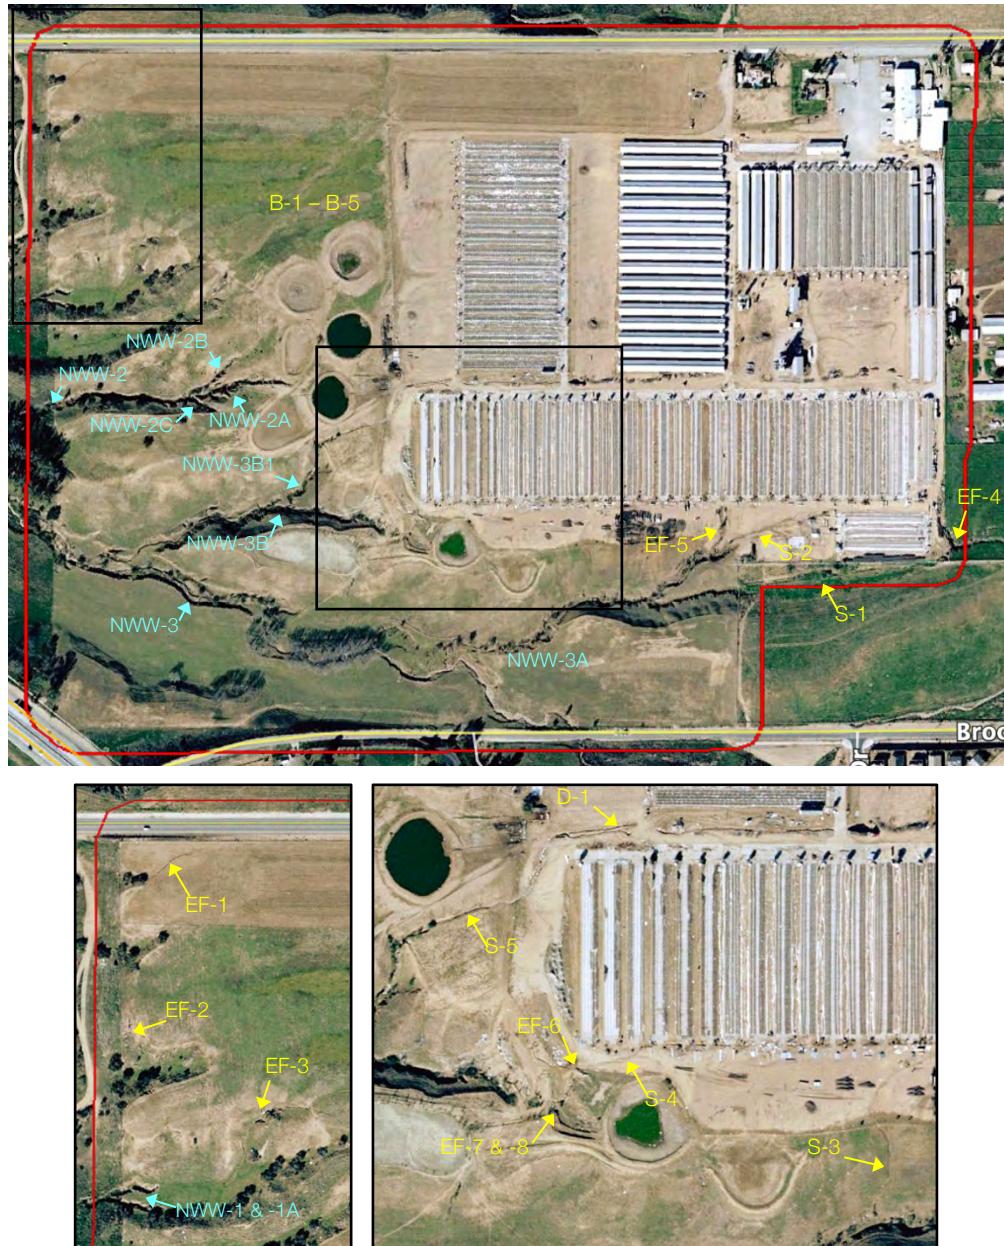
October 2003 – Farming operations within the review area continue to expand between September 1996 and October 2003 with the construction of more poultry sheds in the center of the review area. Additionally, more ponding basins (i.e., B-3 through B-5 and various other unnamed basins) were developed during this time. Remains of these developments and site modifications exist to this day. B-1 and B-2 are still present; however, no longer appear to drain runoff into NWW-2 and NWW-2B. Furthermore, NWW-3B no longer appears to receive flows from the unnamed basin in the center of the review area. NWW-1, NWW-1A, NWW-2, NWW-2B, NWW-2C, NWW-3, and NWW-3A are visible on the aerial in their current locations. The expanding farming operations continue to contribute to further reductions of NWW-3B and NWW-3B1. By October 2003, NWW-3B and NWW-3B1 were reduced to their current extents. NWW-2A is primarily only visible near its convergence with NWW-2.

EF-1 through EF-3 are visible and appear to receive runoff from a new irrigation system within the review area. EF-4 is evident, and EF-5 still appears to receive runoff from the poultry sheds. S-1 is further indistinguishable and appears to likely contain the same characteristics as those observed present-day (i.e., no break in slope or a defined bed and bank between the swale and adjacent uplands). S-2 has reemerged and appears to receive runoff from farming operation buildings. The expansion of the poultry sheds appears to result in S-4 and EF-6 becoming slightly apparent and S-5, EF-7, and EF-8 being visible in their current locations and extents. S-3 and D-1 are not yet apparent.

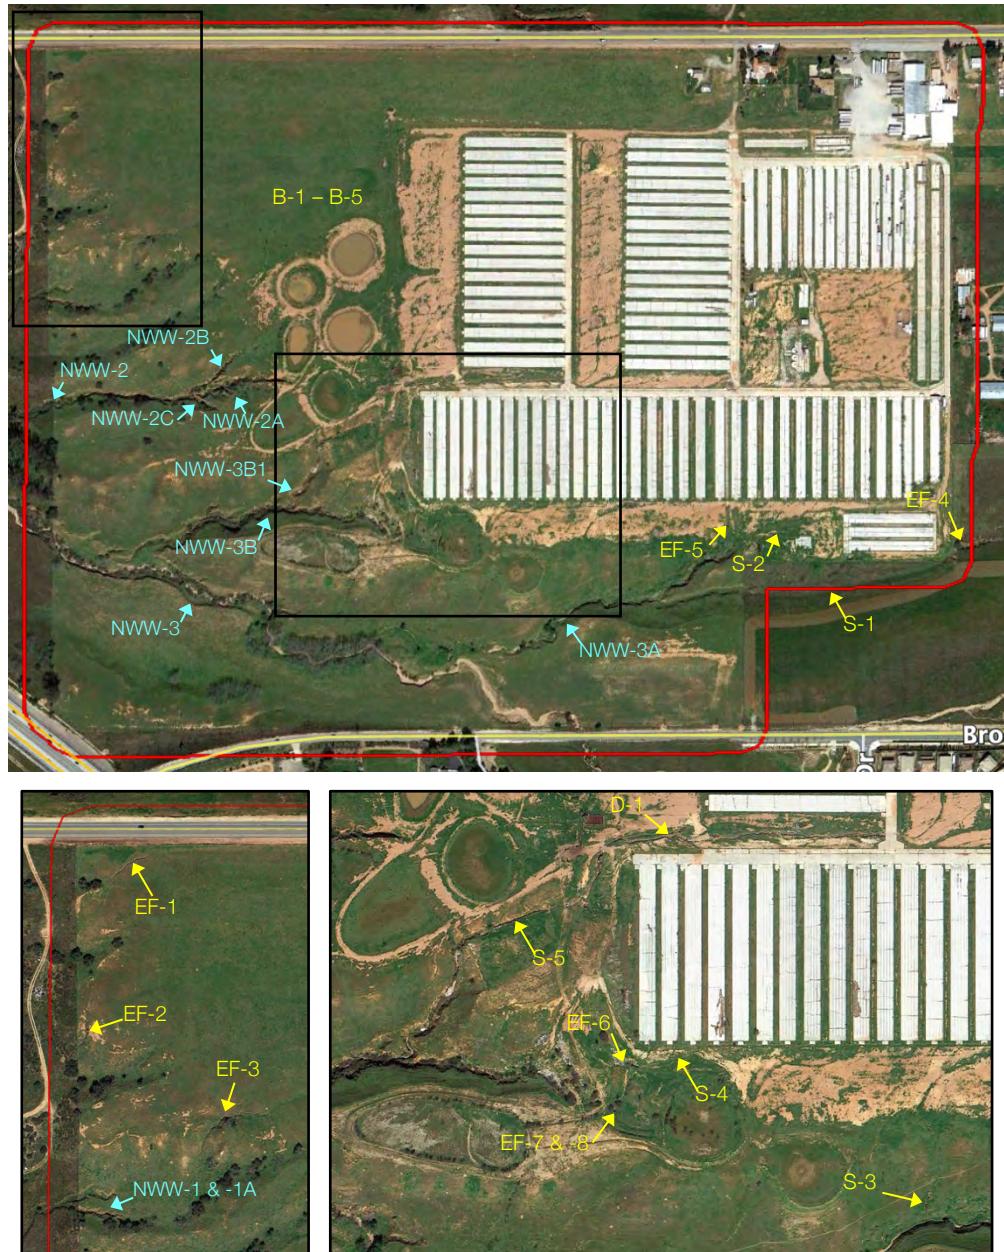
January 2006 – Various poultry sheds throughout the review area were demolished sometime between October 2003 and January 2006. The remaining shed concrete foundations visible in the January 2006 aerial exist to this day. NWW-1, NWW-1A, NWW-2, NWW-2B, NWW-2C, NWW-3, NWW-3A, NWW-3B, and NWW-3B1 are visible in their current locations and extents. NWW-2A is primarily only visible near its convergence with NWW-2.

B-1 through B5 and EF-1 through EF-4 are visible in their current locations. EF-5 and S-2 continue to receive runoff downslope from the farming operations. S-1 is still only defined by the slight concave topography and lacks any other distinguishable features. S-3 has reemerged and is slightly visible in the January 2006 aerial. Active farming activities between October 2003 and January 2006 likely resulted in further defining S-4, S-5, and EF-6 through EF-8. D-1 is now fully evident in the January 2006 aerial. The northernmost poultry sheds appear to create downslope runoff which defined and created D-1 between October 2003 and January 2006.

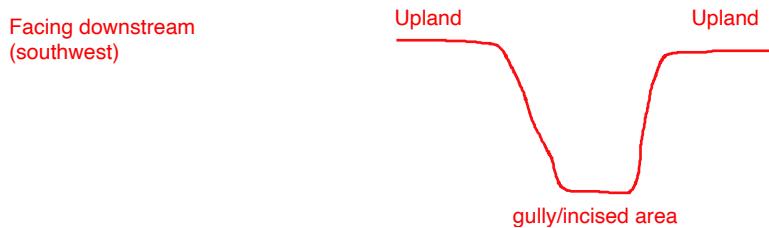
Cross section drawing:

**OHWM**

GPS point: 33.967162, -117.025097

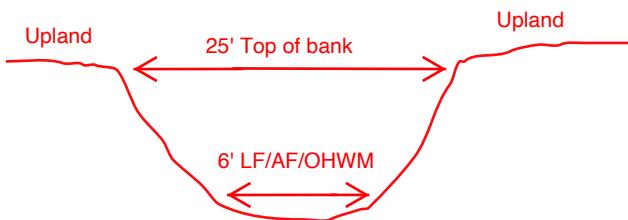
Cross section drawing:

Northern leg of
feature; facing
downstream (west)

**OHWM**

GPS point: 33.966030, -117.024921

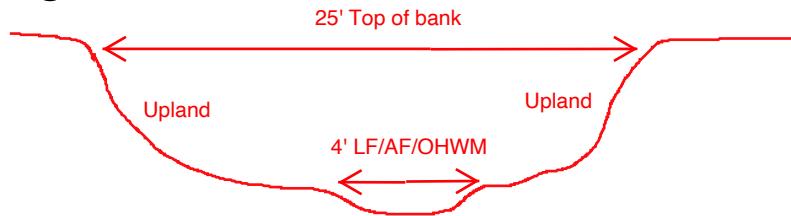
Cross section drawing:

Facing downstream (west)

**OHWM**

GPS point: 33.964891, -117.023514

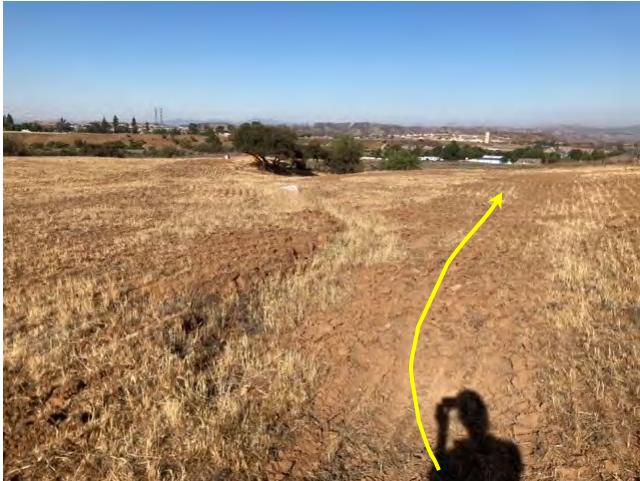
Photo 1. Looking southwest towards Erosional Feature (EF-1) (yellow line). Vegetation surrounding EF-1 had been recently mowed. EF-1 exhibited a slight break in bank slope, but did not exhibit a distinctive change in average sediment texture, change in vegetation species or cover, or any other Ordinary High Water Mark (OHWM) indicators. (33.968462, -117.024590). June 3, 2021.

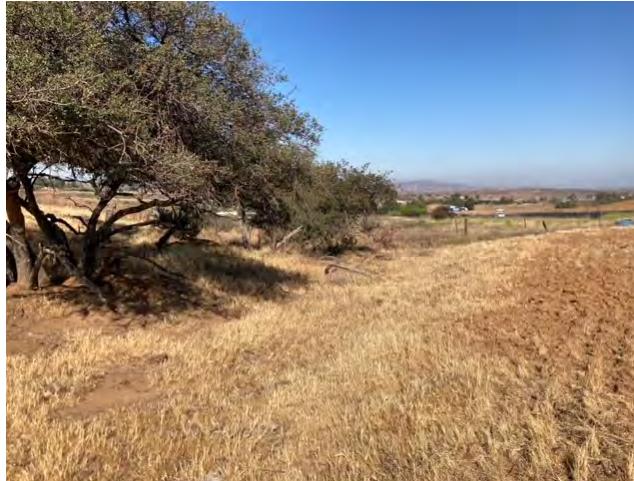
Photo 2. View of OHWM Datasheet Point (ODP) 1, facing west, within the lower topographic area between two gentle slopes just west of EF-1. The lower topographic area did not exhibit any bed and bank indicators, there was no break in slope, and the sediment texture and vegetation did not differ from the lower topographic area to the adjacent slopes (33.968296, -117.024925). June 3, 2021.

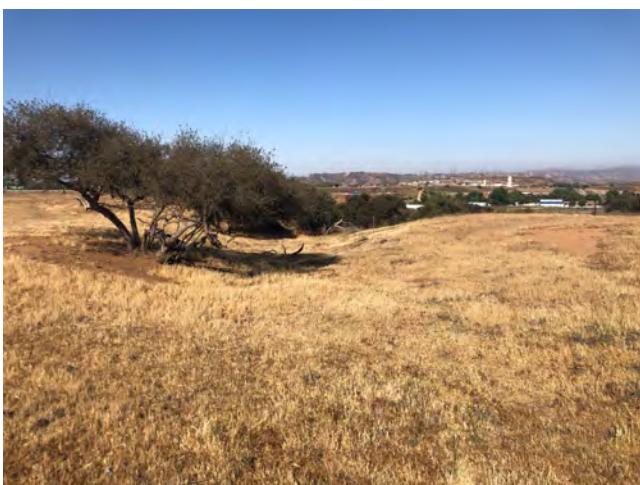
Photo 3. View of area of low topography between EF-1 and EF-2, facing southwest (33.967847, -117.024635). June 3, 2021.

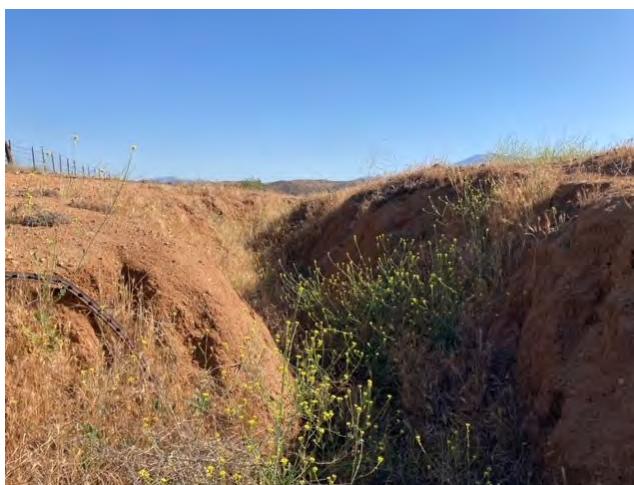
Photo 4. View of ODP 2, facing southwest, within EF-2. The gully/erosional feature exhibited a slight break in bank slope but did not exhibit a distinctive change in average sediment texture, change in vegetation species or cover, or any other OHWM indicators, and did not continue downstream (33.967305, -117.025013). June 3, 2021.

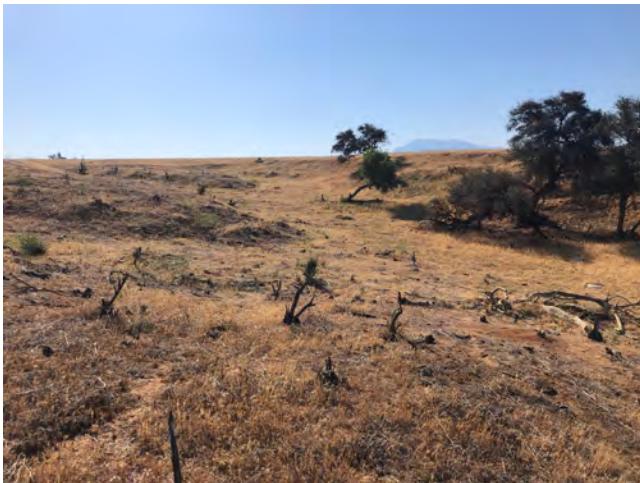
Photo 5. Overview of area of lower topography located east of EF-2, facing east (33.967002, -117.025087). June 3, 2021.

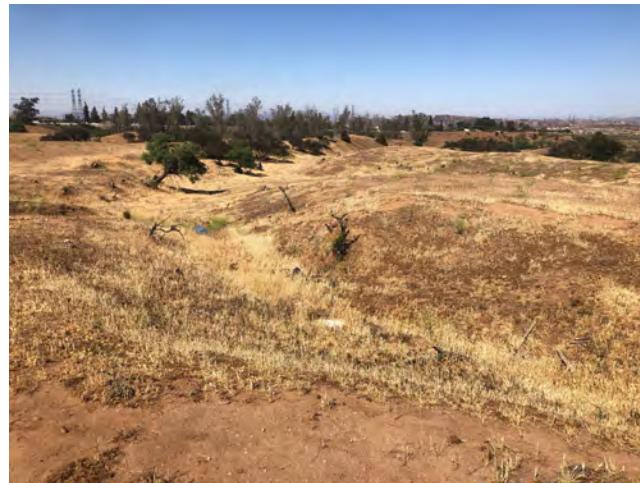
Photo 6. Overview of area of lower topography located west of Basin (B)-2, facing southwest (33.966258, -117.022864). June 3, 2021.

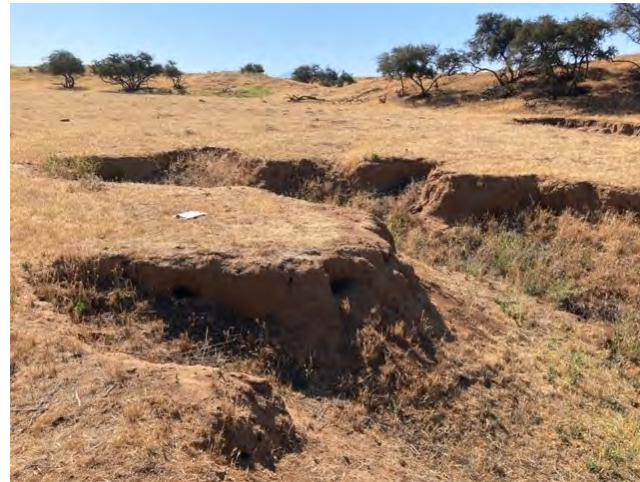
Photo 8. Upstream view of ODP 3, facing southeast, within NWW-1A. The OHWM was defined by a faint break in bank slope and a change in vegetation cover. NWW-1A and NWW-1 continue downstream where OHWM indicators become more prominent (33.966120, -117.025049). June 3, 2021.

Photo 8. Upstream view of ODP 3, facing southeast, within NWW-1A. The OHWM was defined by a faint break in bank slope and a change in vegetation cover. NWW-1A and NWW-1 continue downstream where OHWM indicators become more prominent (33.966120, -117.025049). June 3, 2021.

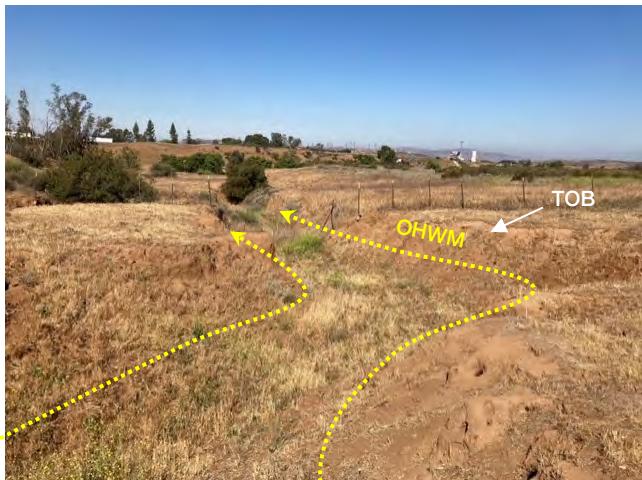
Photo 9. Downstream view of ODP 3, facing west, within NWW-1A. As NWW-1A continues downstream, OHWM indicators become more prominent (33.966076, -117.024773). June 3, 2021.

Photo 9. Downstream view of ODP 3, facing west, within NWW-1A. As NWW-1A continues downstream, OHWM indicators become more prominent (33.966076, -117.024773). June 3, 2021.

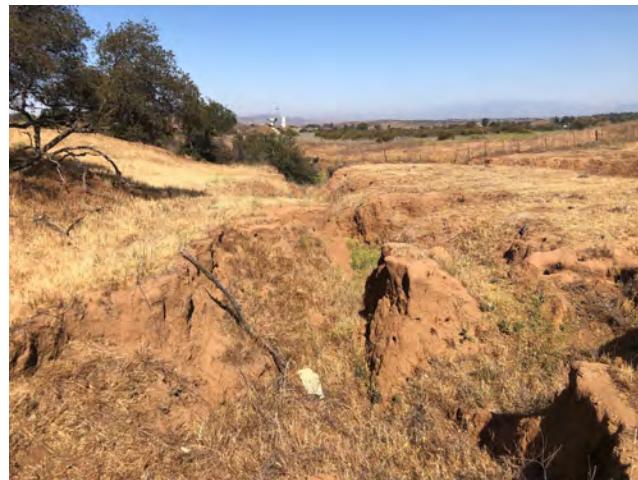
Photo 10. Downstream view of NWW-1 from upstream extent, facing west. As NWW-1 continues downstream, OHWM indicators become more prominent (33.965835, -117.024734). June 3, 2021.

Photo 10. Downstream view of NWW-1 from upstream extent, facing west. As NWW-1 continues downstream, OHWM indicators become more prominent (33.965835, -117.024734). June 3, 2021.

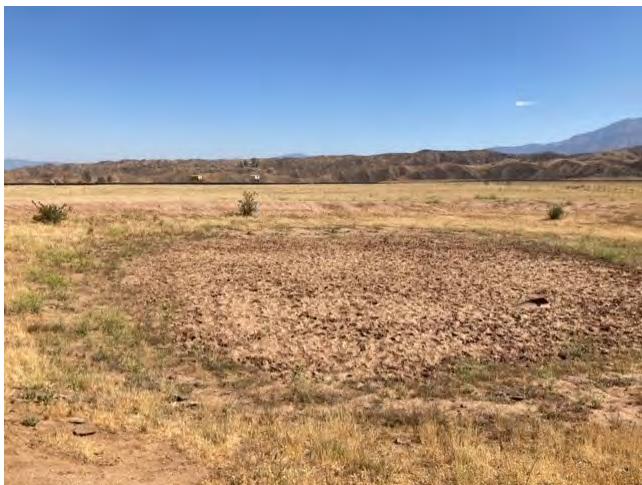
Photo 11. View of B-1, which contained several mulefat (*Baccharis salicifolia*), facing north. B-1 was previously used as a settling basin to hold manure (33.966130, -117.021422). June 3, 2021.

Photo 11. View of B-1, which contained several mulefat (*Baccharis salicifolia*), facing north. B-1 was previously used as a settling basin to hold manure (33.966130, -117.021422). June 3, 2021.

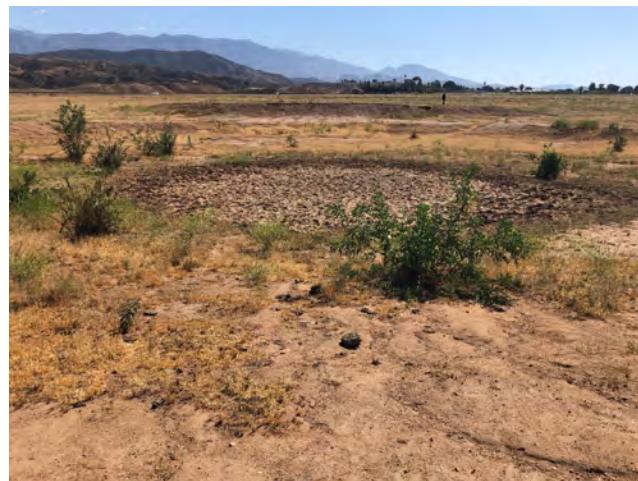
Photo 12. View of B-2, which contained some mulefat and tree tobacco (*Nicotiana glauca*), facing northeast. B-2 was previously used as a settling basin to hold manure (33.966130, -117.021422). June 3, 2021.

Photo 12. View of B-2, which contained some mulefat and tree tobacco (*Nicotiana glauca*), facing northeast. B-2 was previously used as a settling basin to hold manure (33.966130, -117.021422). June 3, 2021.

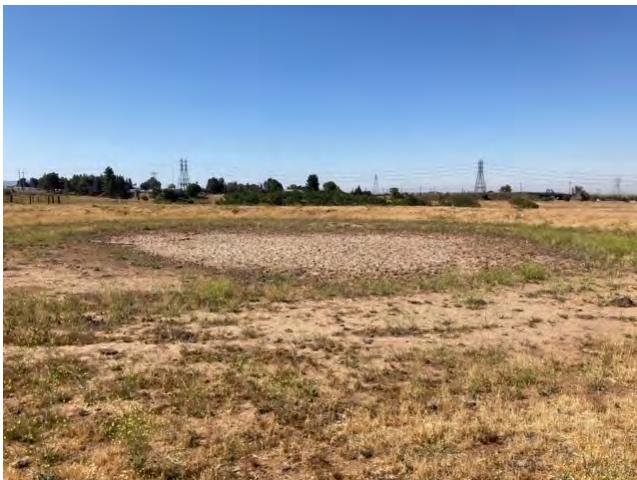
Photo 13. View of B-3, facing south. B-3 was previously used as a settling basin to hold manure (33.965818, -117.021455). June 3, 2021.

Photo 13. View of B-3, facing south. B-3 was previously used as a settling basin to hold manure (33.965818, -117.021455). June 3, 2021.

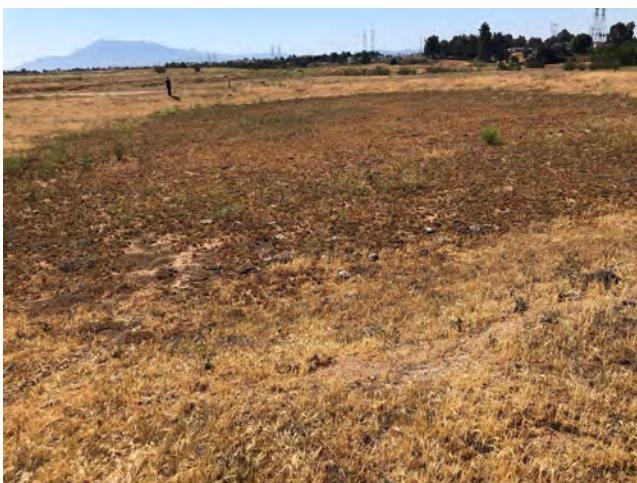
Photo 15. View of B-5 facing southeast. B-5 was previously used as a settling basin to hold manure (33.965122 -117.021874). June 3, 2021.

Photo 15. View of B-5 facing southeast. B-5 was previously used as a settling basin to hold manure (33.965122 -117.021874). June 3, 2021.

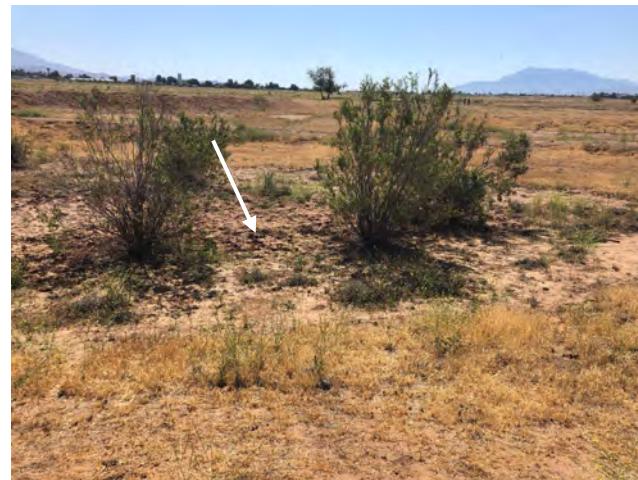
Photo 14. View of Wetland Data Form Point (WDP) 1 (white arrow) within small stand of mule fat, facing east, within B-4. WDP 1 met the wetland hydrology parameter; however, hydrophytic vegetation and hydric soil parameters were not met at WDP 1. B-4 was previously used as a settling basin to hold manure (33.965370, -117.022221). June 3, 2021.

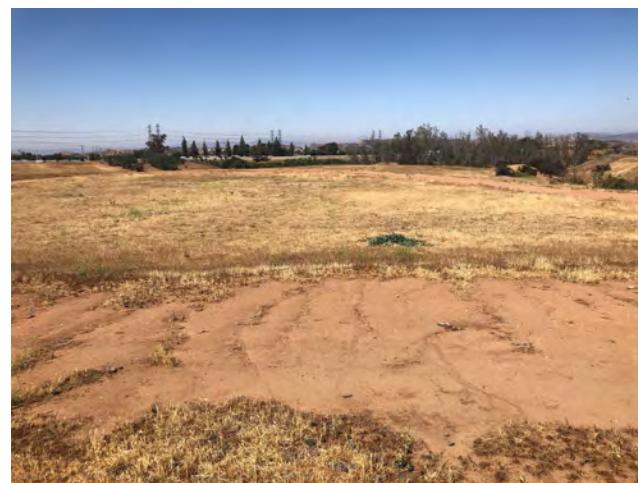
Photo 16. View of area mapped by U.S. Geological Survey (USGS) National Hydrography Dataset (NHD) as a "Reservoir," facing west. No evidence of hydrology was observed (33.965010, -117.021979). June 3, 2021.

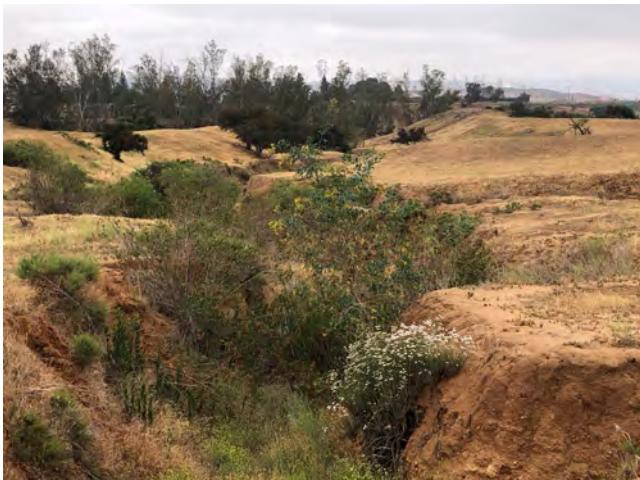
Photo 17. Downstream view of NWW-2, facing west. (33.965125, -117.022334). June 7, 2021.

Photo 17. Downstream view of NWW-2, facing west. (33.965125, -117.022334). June 7, 2021.

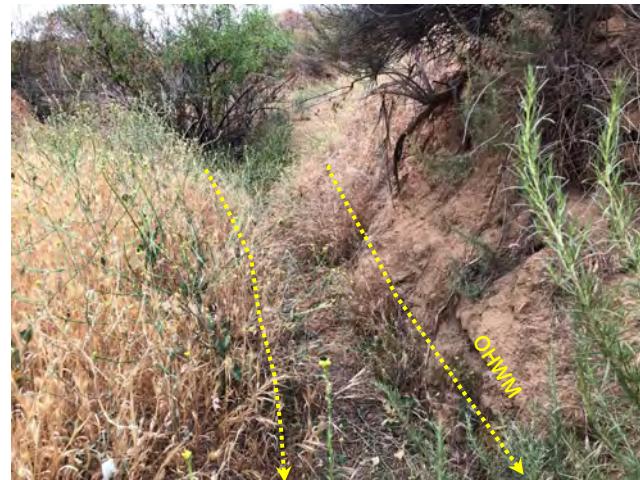
Photo 18. Upstream view of ODP 4, facing east, within NWW-2. The OHWM was defined by a faint break in bank slope and a change in vegetation cover (33.964853, -117.023670). June 7, 2021.

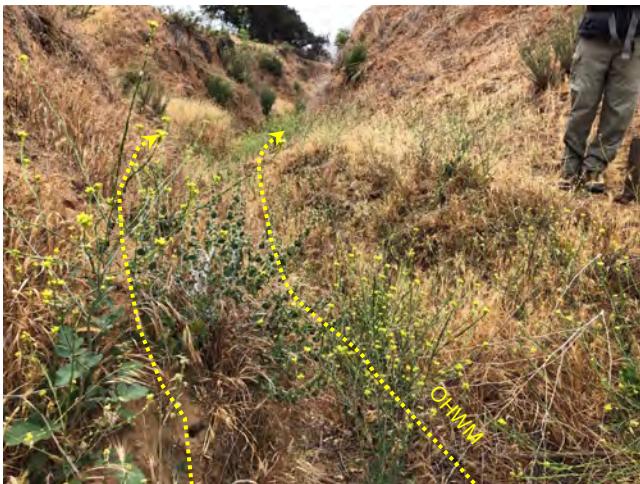
Photo 19. Downstream view of ODP 4, facing west, within NWW-2. Vegetation was dominated by non-native grasses, including short-pod mustard (*Hirschfeldia incana*), ripgut brome (*Bromus diandrus*), and false brome (*Brachypodium distachyon*) (33.964874, -117.023356). June 7, 2021.

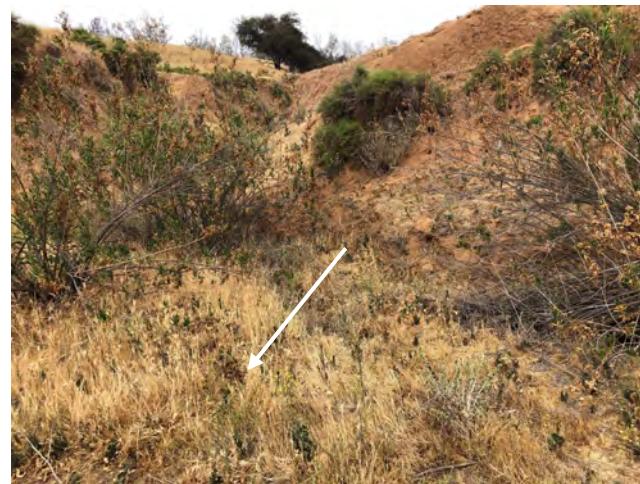
Photo 20. View of WDP 2 (white arrow), facing west, within NWW-2. WDP 2 did not meet the hydrophytic vegetation, hydric soil, or wetland hydrology parameters (33.964962, -117.023251). June 7, 2021.

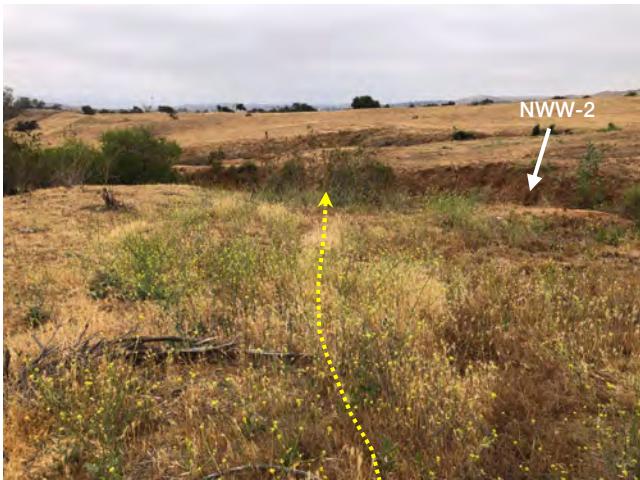
Photo 21. View of NWW-2A (yellow line), which showed faint indicators of an OHWM, as it continues into NWW-2, facing northwest (33.964876, -117.022516). June 7, 2021.

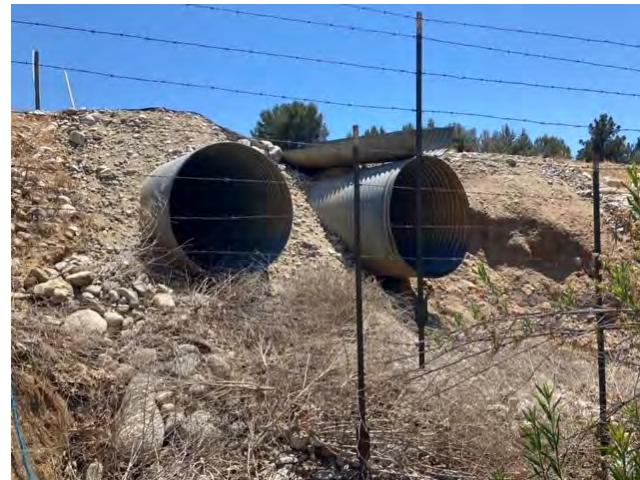
Photo 22. View of culvert outlets located along the southern extent of the review area under Brookside Avenue, facing south. Flows from the culvert outlets continue into NWW-3 (33.961603, -117.018517). June 3, 2021.

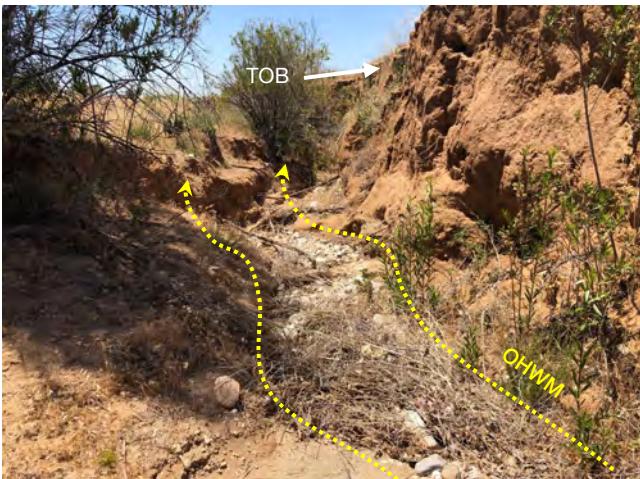
Photo 23. Downstream view of NWW-3, facing northwest, located just north of the two culvert outlets under Brookside Avenue before NWW-3 converges with NWW-3A (33.961636, -117.018604). June 3, 2021.

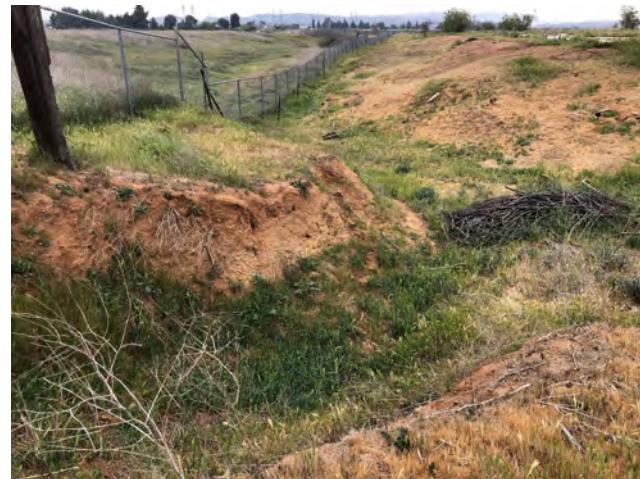
Photo 24. View of EF-4 within the review area, facing west. EF-4 continues west into Swale (S)-1, which ultimately converges with NWW-3A (33.963245, -117.013837). April 22, 2021.

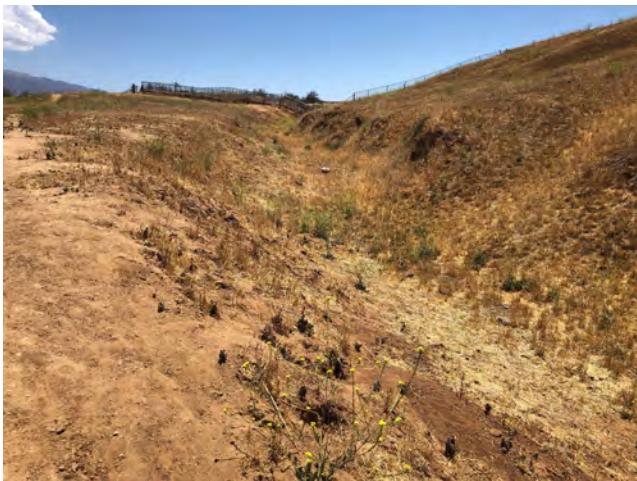
Photo 25. View of ODP 6, facing east, within S-1. S-1 did not exhibit any bed and bank indicators, there was no change in sediment texture or break in slope, and vegetation did not differ between the swale and the adjacent upland area (33.962812, -117.017420). June 3, 2021.

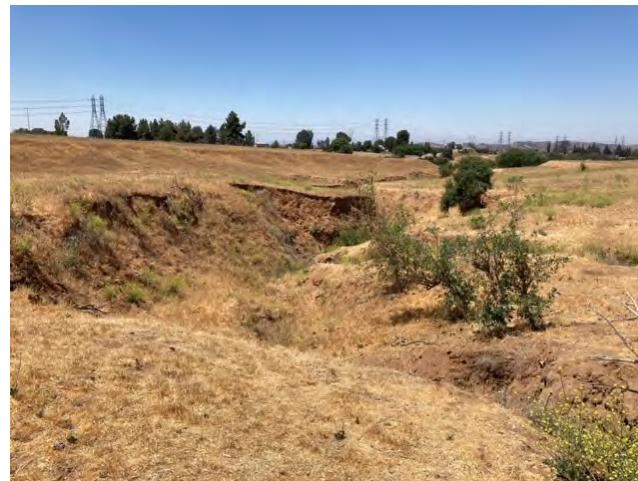
Photo 26. View at upstream extent of NWW-3A, facing southwest, just west of S-2 (33.963458, -117.016526). June 3, 2021.

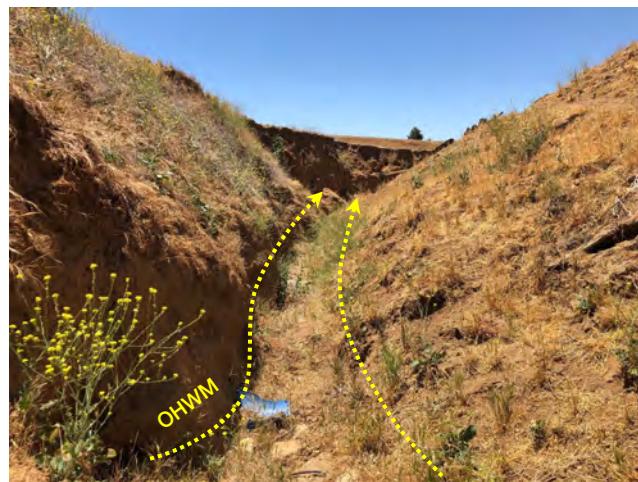
Photo 28. Downstream view of ODP 5, facing southwest, within NWW-3A (33.963266, -117.017032). June 3, 2021.

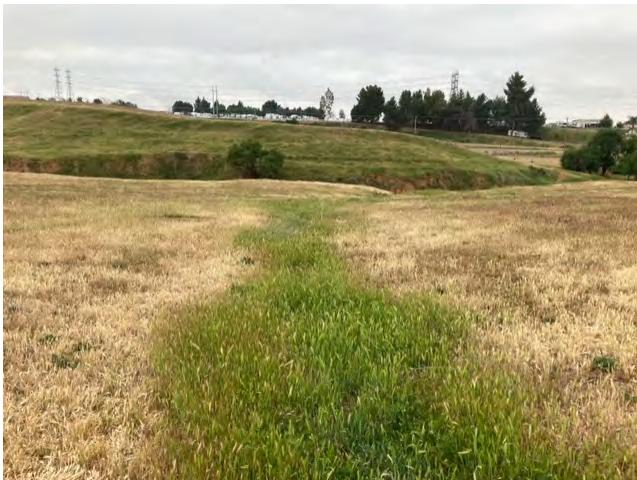
Photo 29. View of S-3, facing south, as it travels towards NWW-3A (33.9632961, -117.018316). April 22, 2021.

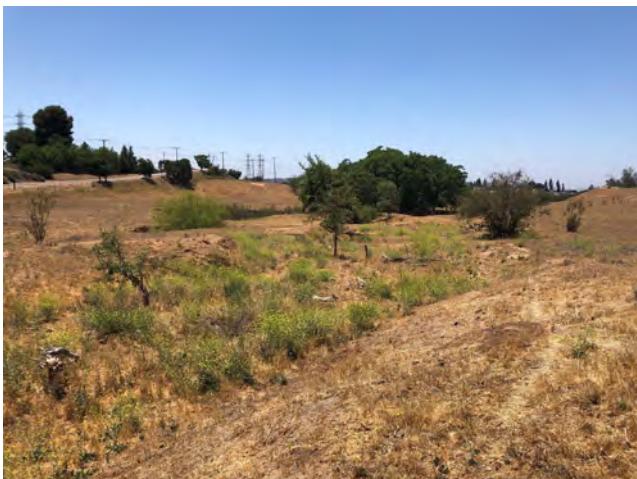
Photo 31. Downstream view of area of NWW-3A exhibiting a faint OHWM, facing west (33.962373, -117.019364). June 3, 2021.

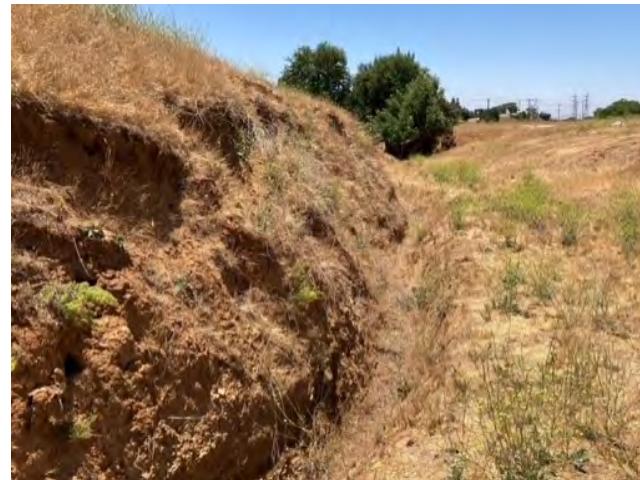
Photo 30. Downstream view of NWW-3A, facing southwest (33.962811, -117.018492). June 3, 2021.

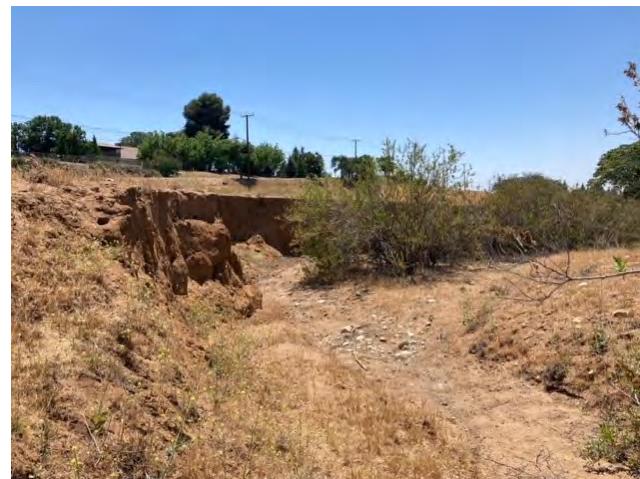
Photo 32. Downstream view of NWW-3, located west of the convergence of NWW-3 and NWW-3A, facing southwest (33.962054, -117.02037). June 3, 2021.

Photo 32. Downstream view of NWW-3, located west of the convergence of NWW-3 and NWW-3A, facing southwest (33.962054, -117.02037). June 3, 2021.

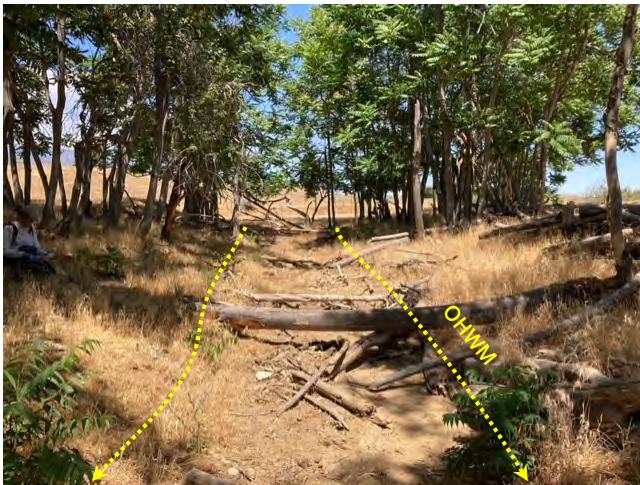
Photo 33. Upstream view of ODP 7, facing east, within NWW-3. The OHWM was primarily defined by a change in average sediment texture, change in vegetation species and cover, and faint break in bank slope (33.962257, -117.021513).

Photo 33. Upstream view of ODP 7, facing east, within NWW-3. The OHWM was primarily defined by a change in average sediment texture, change in vegetation species and cover, and faint break in bank slope (33.962257, -117.021513).

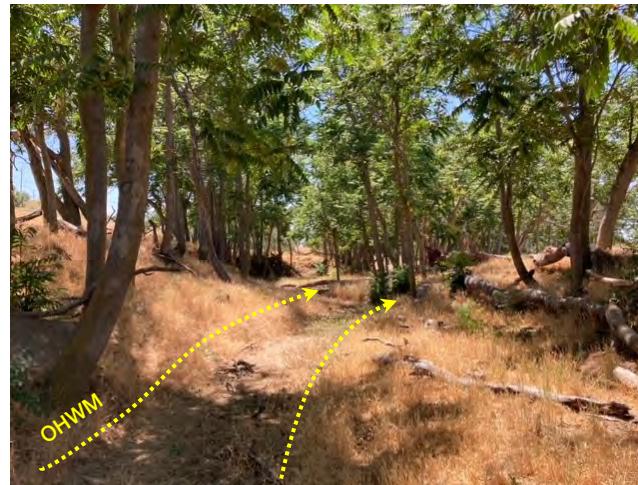
Photo 34. Downstream view of ODP 7, facing west, within NWW-3 (33.962335, -117.021187). June 3, 2021.

Photo 34. Downstream view of ODP 7, facing west, within NWW-3 (33.962335, -117.021187). June 3, 2021.

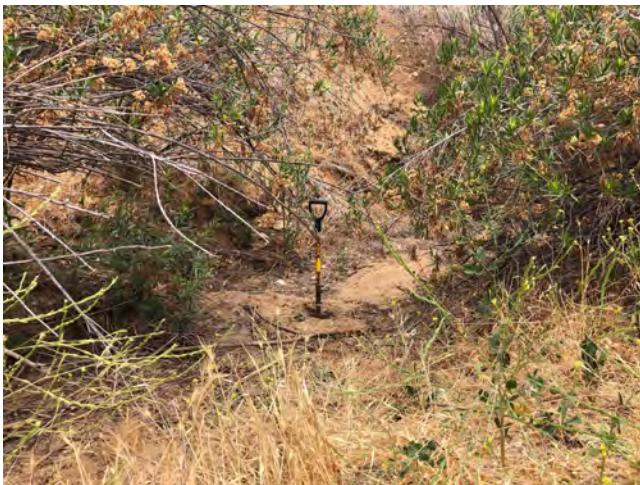
Photo 35. View of WDP 3, facing north, within NWW-3. WDP 3 met the hydrophytic vegetation parameter; however, hydric soil and wetland hydrology parameters were not met within WDP 3 (33.962696, -117.022892). June 7, 2021.

Photo 35. View of WDP 3, facing north, within NWW-3. WDP 3 met the hydrophytic vegetation parameter; however, hydric soil and wetland hydrology parameters were not met within WDP 3 (33.962696, -117.022892). June 7, 2021.

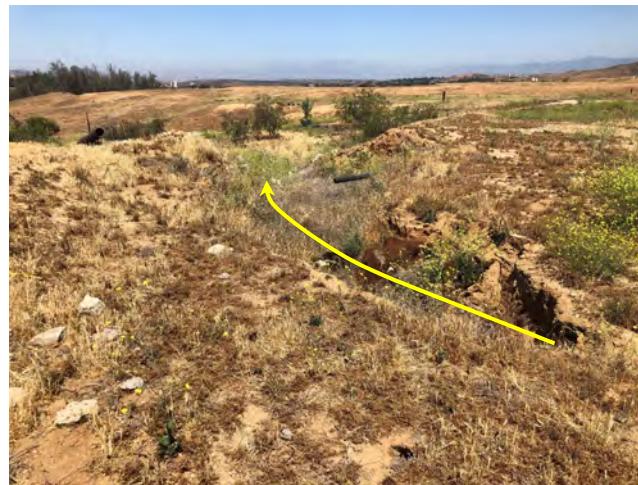
Photo 36. View of EF-6 (yellow line), facing northwest, which travels into area with some mulefat and tree tobacco, just east of NWW-3B. EF-6 did not appear to contribute flows to NWW-3B (33.963667, -117.020341). June 3, 2021.

Photo 36. View of EF-6 (yellow line), facing northwest, which travels into area with some mulefat and tree tobacco, just east of NWW-3B. EF-6 did not appear to contribute flows to NWW-3B (33.963667, -117.020341). June 3, 2021.

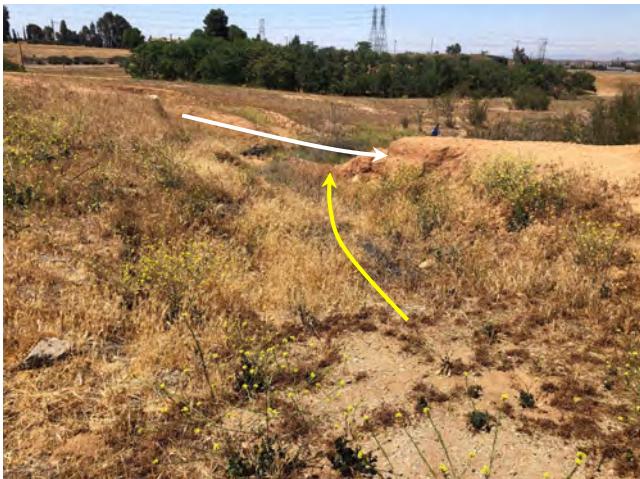
Photo 37. View of EF-7 (yellow arrow), just south of EF-6, facing south/southwest. EF-7 converges with EF-8 (white arrow), neither of which appeared to contribute flows to NWW-3B (33.963581, -117.020494). June 3, 2021.

Photo 37. View of EF-7 (yellow arrow), just south of EF-6, facing south/southwest. EF-7 converges with EF-8 (white arrow), neither of which appeared to contribute flows to NWW-3B (33.963581, -117.020494). June 3, 2021.

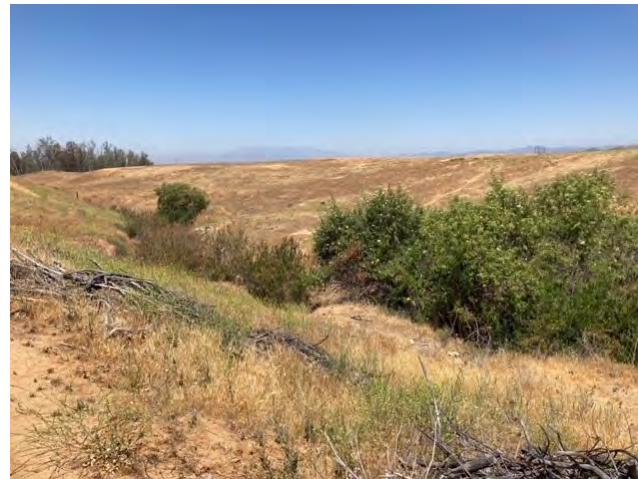
Photo 38. Looking downstream from the south side of the upstream extent of NWW-3B, facing northwest (33.963553, -117.021142). June 3, 2021.

Photo 38. Looking downstream from the south side of the upstream extent of NWW-3B, facing northwest (33.963553, -117.021142). June 3, 2021.

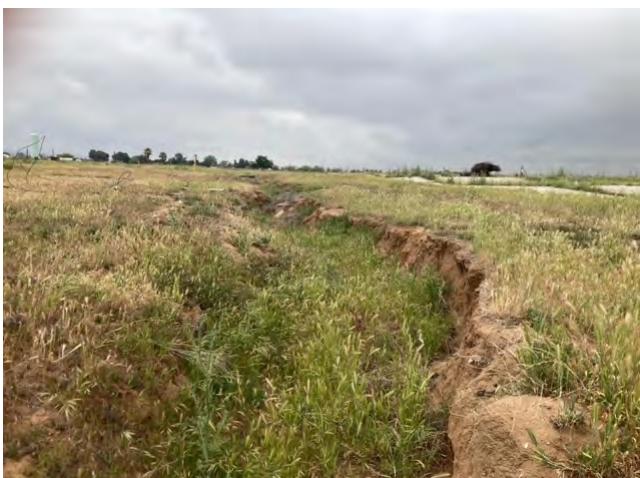
Photo 39. View of D-1, facing east (33.965103, -117.019365). April 22, 2021.

Photo 39. View of D-1, facing east (33.965103, -117.019365). April 22, 2021.

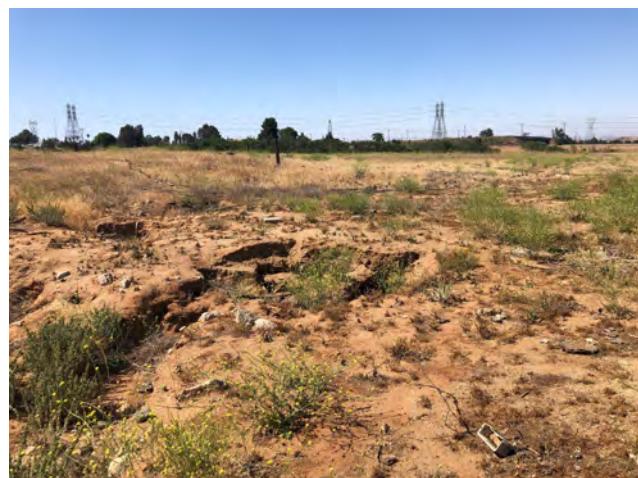
Photo 40. View of area where D-1 abruptly stops, facing south. Flows likely continue as sheet flow into S-5, before continuing into NWW-3B1 (33.964824, -117.020845). June 3, 2021.

Photo 40. View of area where D-1 abruptly stops, facing south. Flows likely continue as sheet flow into S-5, before continuing into NWW-3B1 (33.964824, -117.020845). June 3, 2021.

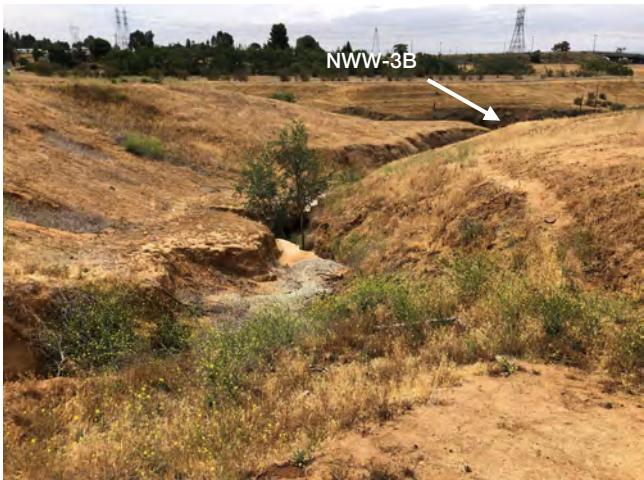
Photo 41. View of NWW-3B1, facing south. Flows continue south/southwest into NWW-3B (white arrow) (33.964550, -117.021793). June 3, 2021.

Photo 41. View of NWW-3B1, facing south. Flows continue south/southwest into NWW-3B (white arrow) (33.964550, -117.021793). June 3, 2021.

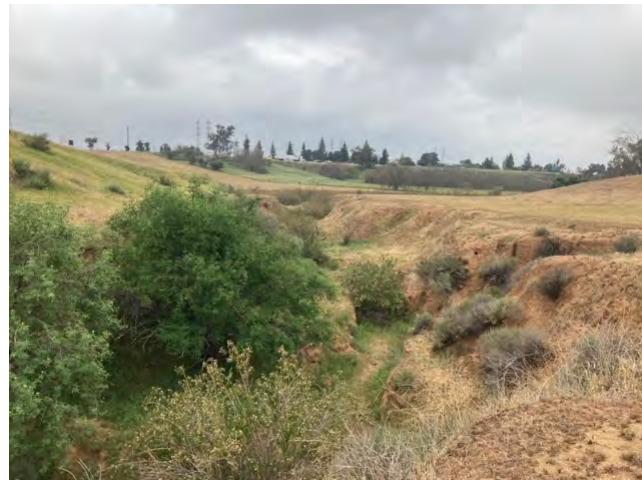
Photo 42. Downstream view of NWW-3B, facing west (33.963775, -117.022856). April 22, 2021.

Photo 42. Downstream view of NWW-3B, facing west (33.963775, -117.022856). April 22, 2021.
