Section 3.0 Errata

In accordance with Section 15132 of the CEQA Guidelines, the FEIR for the Beaumont Summit Station Project includes the DEIR, dated April 2022, as well as any proposed revisions or changes to the DEIR.

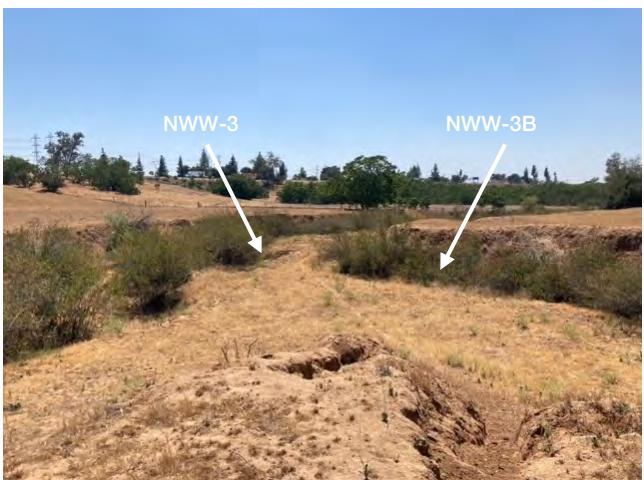
Photo 43. Downstream view of the convergence of NWW-3 and NWW-3B, facing west, before NWW-3 continues off site (33.963316, -117.023726). June 3, 2021.

Photo 43. Downstream view of the convergence of NWW-3 and NWW-3B, facing west, before NWW-3 continues off site (33.963316, -117.023726). June 3, 2021.

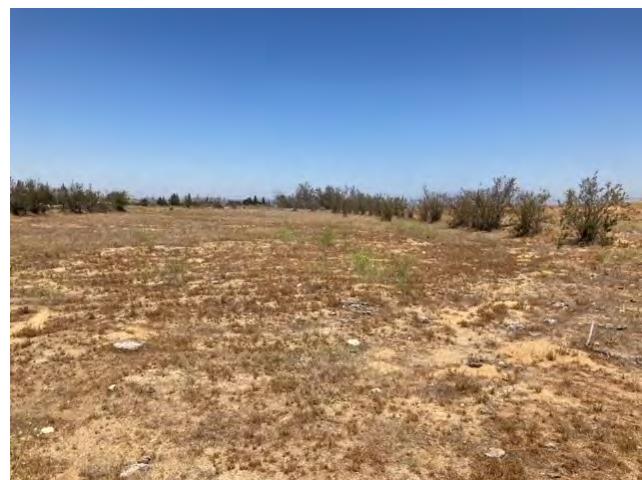
Photo 44. View of slight depressional area surrounded by mulefat scrub, located south of NWW-3B, facing west. No evidence of hydrology was observed (33.963283, -117.021269). June 3, 2021.

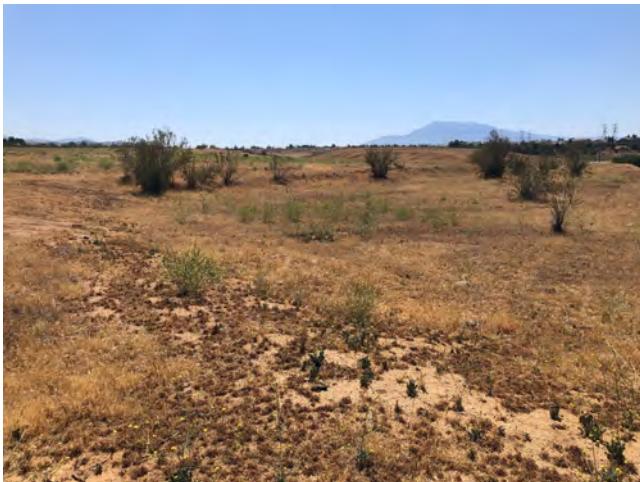
Photo 45. East facing view of area mapped by USGS NHD as a "Reservoir" and where a basin was previously located east of EF-8. No evidence of hydrology was observed (33.963493, -117.020227). June 3, 2021.

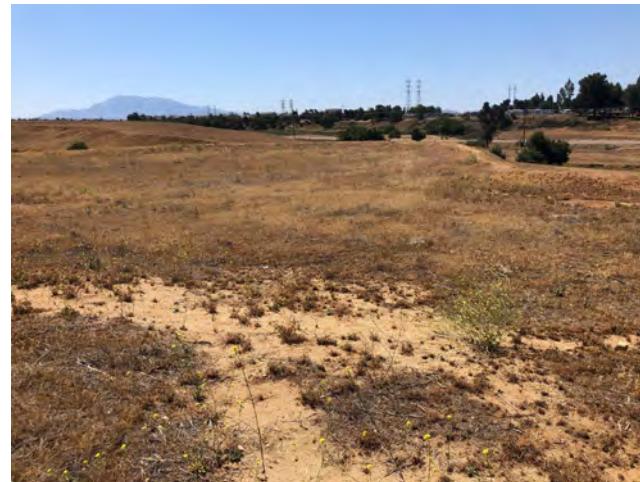
Photo 46. Southeast facing view of area where a basin was previously located west of S-3. No evidence of hydrology was observed (33.963274, -117.019648). June 3, 2021.

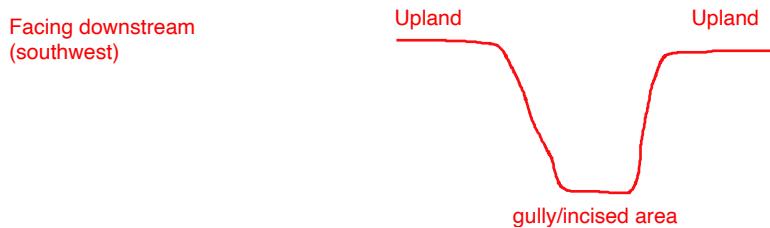
Cross section drawing:

**OHWM**

GPS point: 33.967162, -117.025097

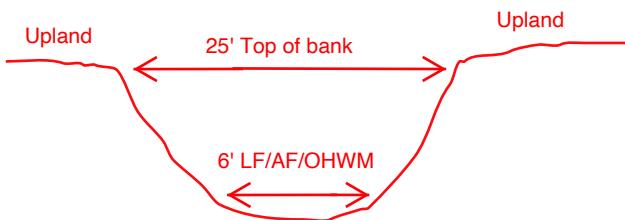
Cross section drawing:

Northern leg of
feature; facing
downstream (west)

**OHWM**

GPS point: 33.966030, -117.024921

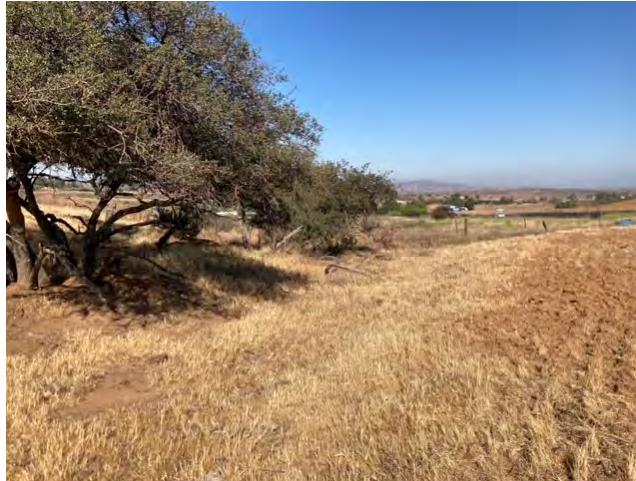
Photo 2. View of OHWM Datasheet Point (ODP) 1, facing west, within the lower topographic area between two gentle slopes just west of EF-1. The lower topographic area did not exhibit any bed and bank indicators, there was no break in slope, and the sediment texture and vegetation did not differ from the lower topographic area to the adjacent slopes (33.968296, -117.024925). June 3, 2021.

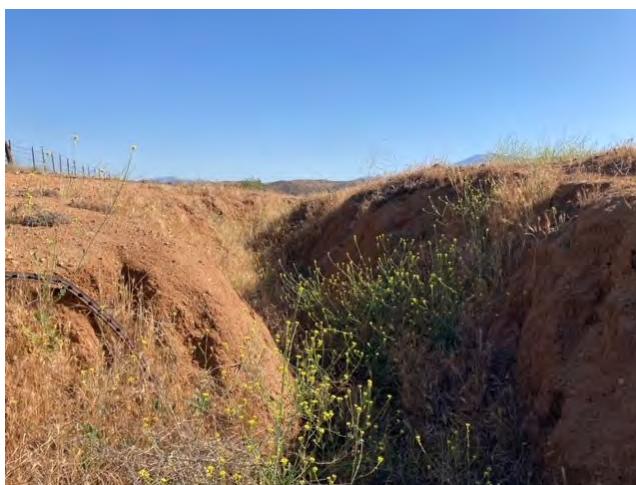
Photo 4. View of ODP 2, facing southwest, within EF-2. The gully/erosional feature exhibited a slight break in bank slope but did not exhibit a distinctive change in average sediment texture, change in vegetation species or cover, or any other OHWM indicators, and did not continue downstream (33.967305, -117.025013). June 3, 2021.

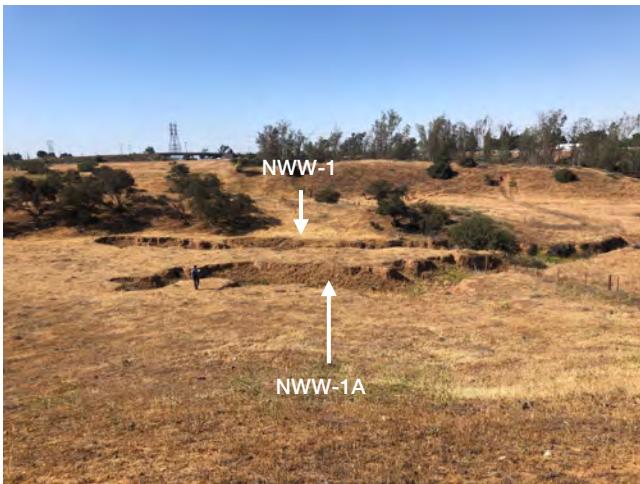
Photo 7. Overview of Non-Wetland Water (NWW)-1A and NWW-1, facing south. NWW-1A and NWW-1 converge just before continuing off site and downstream and exhibiting a more defined bed and bank (33.966304, -117.025167). June 3, 2021.

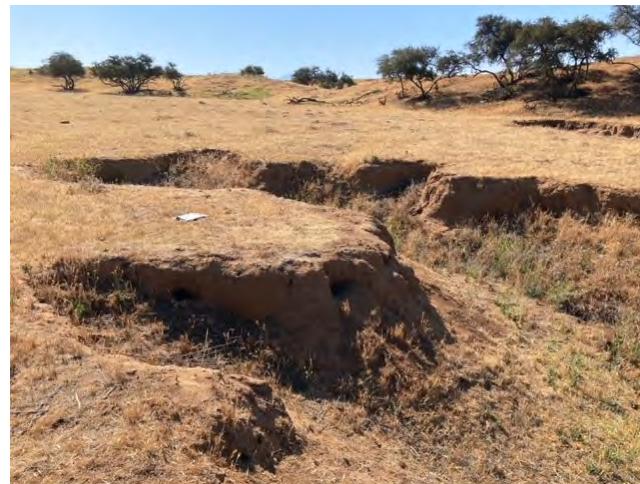
Photo 8. Upstream view of ODP 3, facing southeast, within NWW-1A. The OHWM was defined by a faint break in bank slope and a change in vegetation cover. NWW-1A and NWW-1 continue downstream where OHWM indicators become more prominent (33.966120, -117.025049). June 3, 2021.

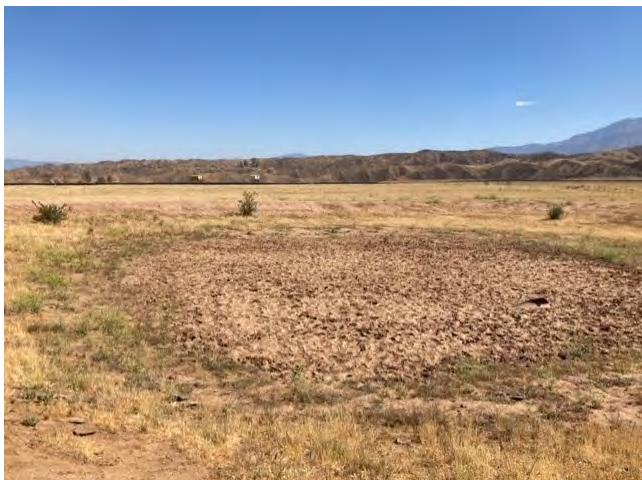
Photo 11. View of B-1, which contained several mulefat (*Baccharis salicifolia*), facing north. B-1 was previously used as a settling basin to hold manure (33.966130, -117.021422). June 3, 2021.

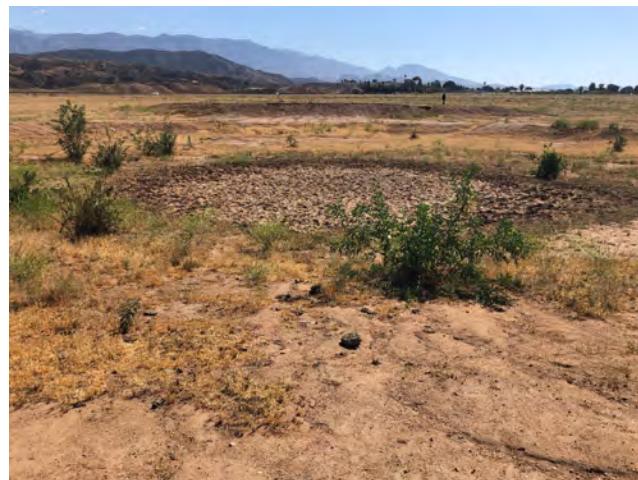
Photo 12. View of B-2, which contained some mulefat and tree tobacco (*Nicotiana glauca*), facing northeast. B-2 was previously used as a settling basin to hold manure (33.966130, -117.021422). June 3, 2021.

Photo 12. View of B-2, which contained some mulefat and tree tobacco (*Nicotiana glauca*), facing northeast. B-2 was previously used as a settling basin to hold manure (33.966130, -117.021422). June 3, 2021.

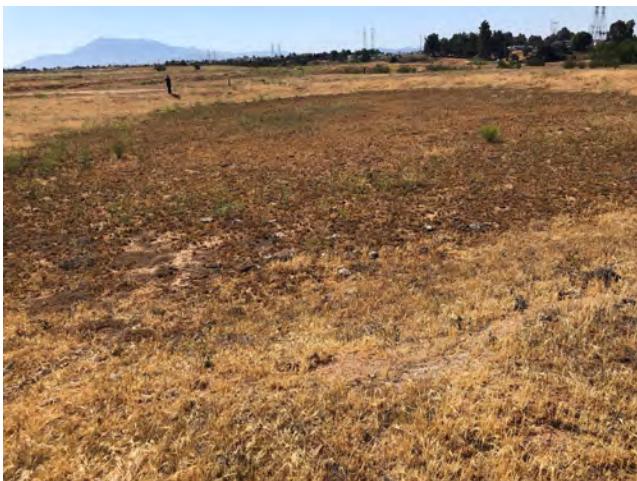
Photo 15. View of B-5 facing southeast. B-5 was previously used as a settling basin to hold manure (33.965122 -117.021874). June 3, 2021.

Photo 15. View of B-5 facing southeast. B-5 was previously used as a settling basin to hold manure (33.965122 -117.021874). June 3, 2021.

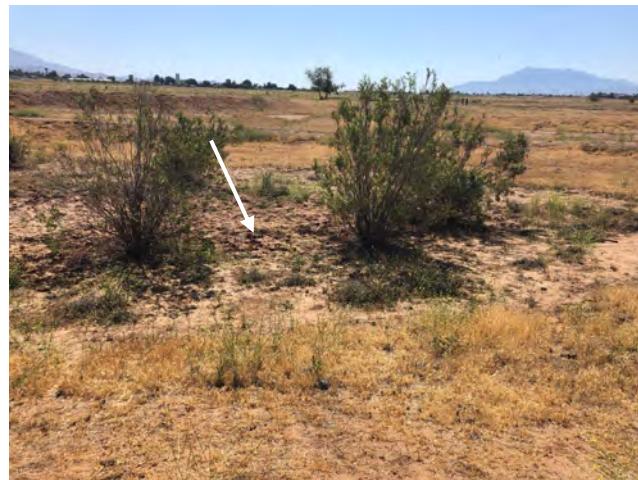
Photo 14. View of Wetland Data Form Point (WDP) 1 (white arrow) within small stand of mule fat, facing east, within B-4. WDP 1 met the wetland hydrology parameter; however, hydrophytic vegetation and hydric soil parameters were not met at WDP 1. B-4 was previously used as a settling basin to hold manure (33.965370, -117.022221). June 3, 2021.

Photo 14. View of Wetland Data Form Point (WDP) 1 (white arrow) within small stand of mule fat, facing east, within B-4. WDP 1 met the wetland hydrology parameter; however, hydrophytic vegetation and hydric soil parameters were not met at WDP 1. B-4 was previously used as a settling basin to hold manure (33.965370, -117.022221). June 3, 2021.

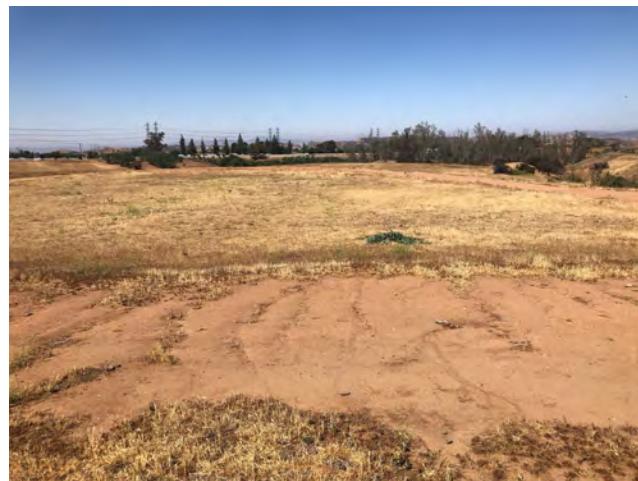
Photo 16. View of area mapped by U.S. Geological Survey (USGS) National Hydrography Dataset (NHD) as a "Reservoir," facing west. No evidence of hydrology was observed (33.965010, -117.021979). June 3, 2021.

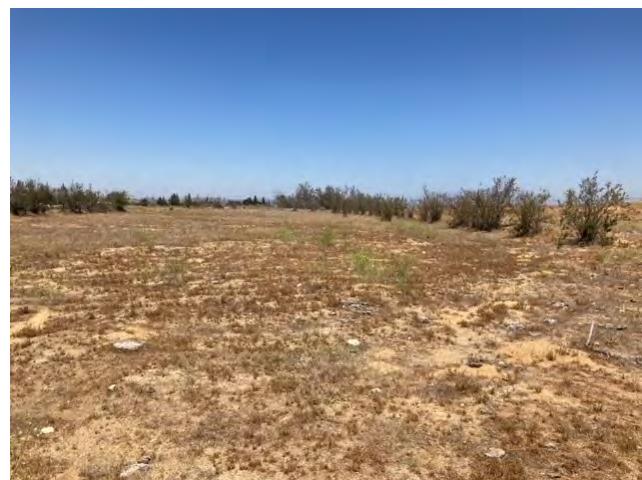
Photo 44. View of slight depressional area surrounded by mulefat scrub, located south of NWW-3B, facing west. No evidence of hydrology was observed (33.963283, -117.021269). June 3, 2021.

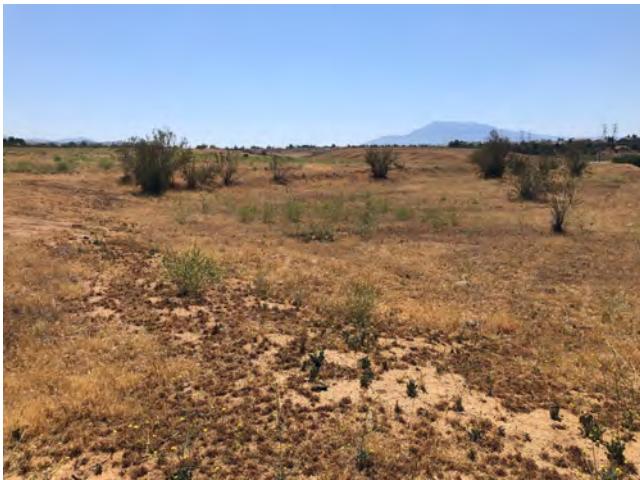
Photo 45. East facing view of area mapped by USGS NHD as a "Reservoir" and where a basin was previously located east of EF-8. No evidence of hydrology was observed (33.963493, -117.020227). June 3, 2021.

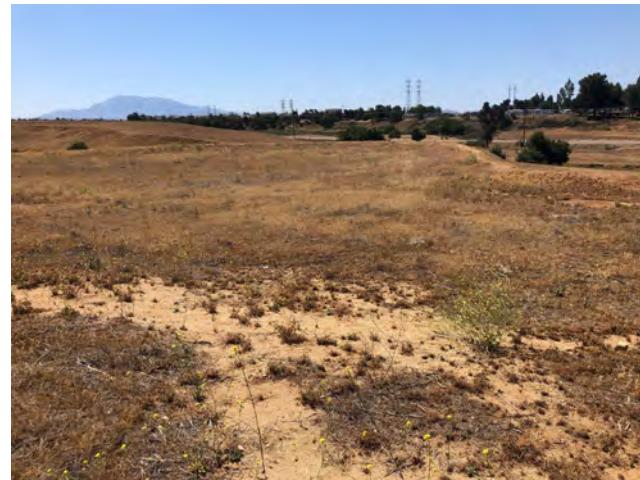
Photo 46. Southeast facing view of area where a basin was previously located west of S-3. No evidence of hydrology was observed (33.963274, -117.019648). June 3, 2021.

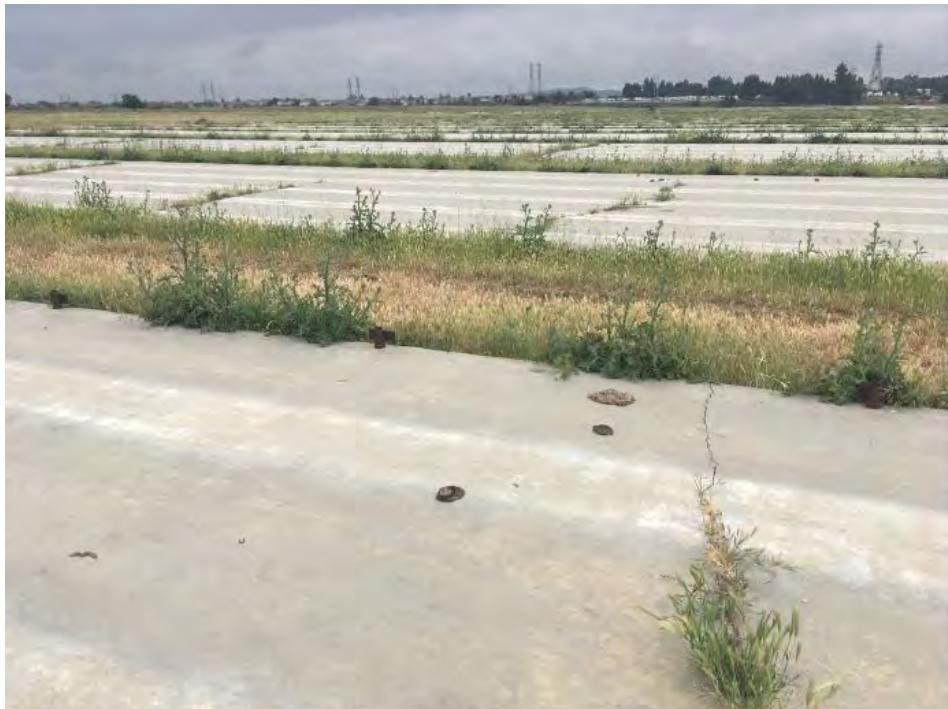
Photo 4. Picture of concrete pads within the central portion of the project, facing south on April 22, 2021.

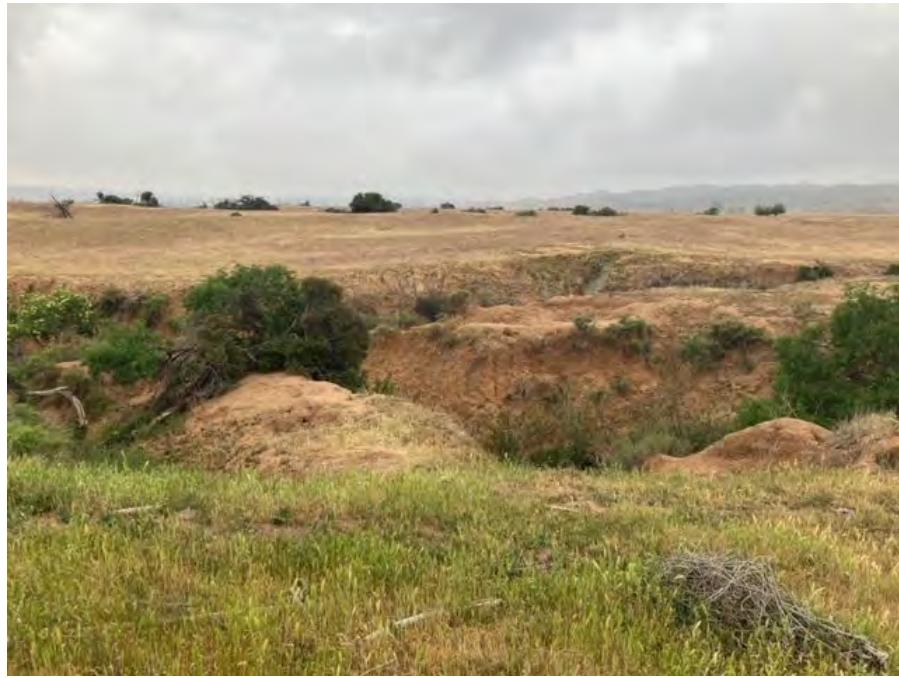
Photo 7. Representative picture of the drainages within the southwestern portion of the project site, facing east on April 22, 2021.

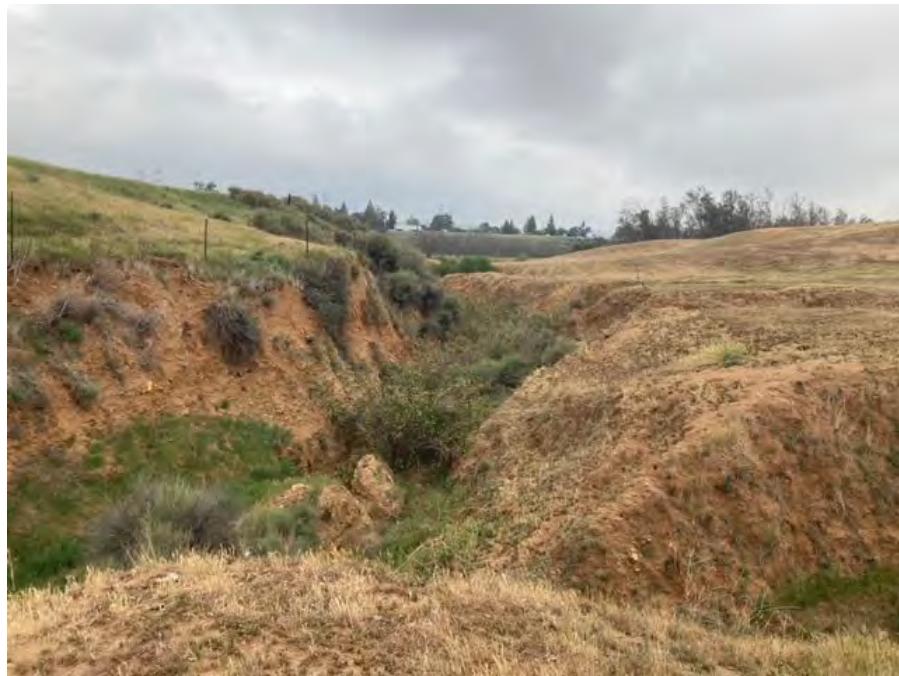
Photo 8. Representative picture of the drainages within the southwestern portion of the project site, facing north on April 22, 2021.

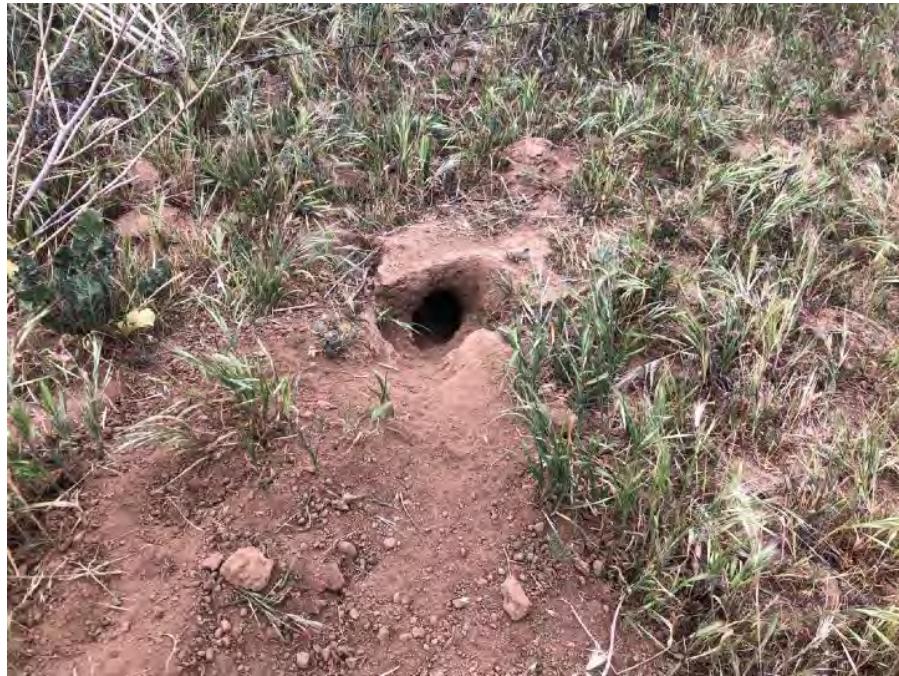
Photo 9. Representative photo of the small-mammal burrows throughout the non-native grassland within the survey area.

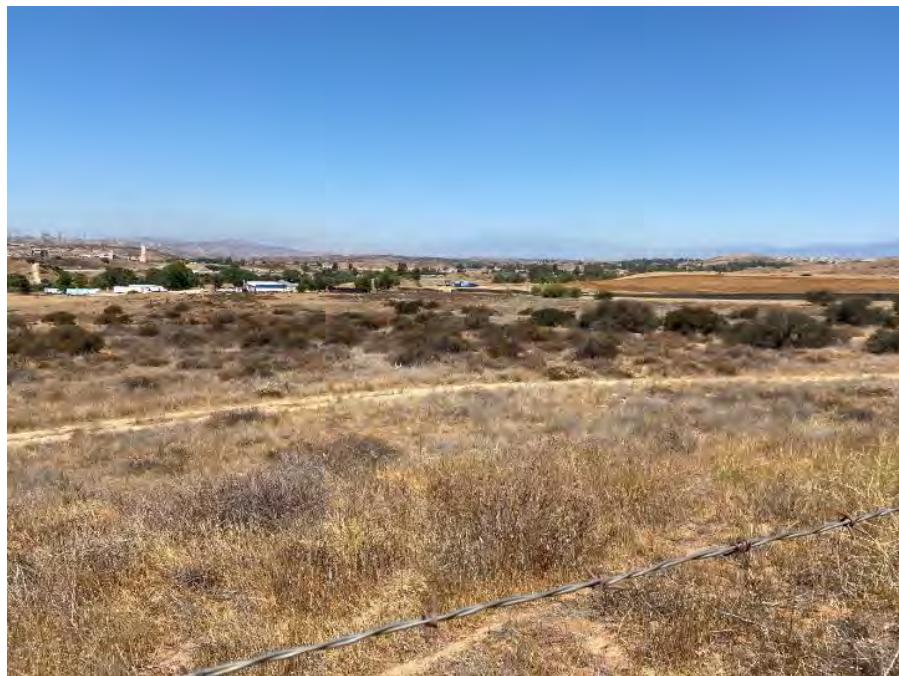
Photo 10. Representative photo of the adjacent chamise chaparral habitat northwest of project boundary on July 20, 2021.
